Bridge Repurposing Study

Willamette River (Van Buren Street) Bridge **Bridge No. 02728** *Benton County, Oregon*

June 14, 2019

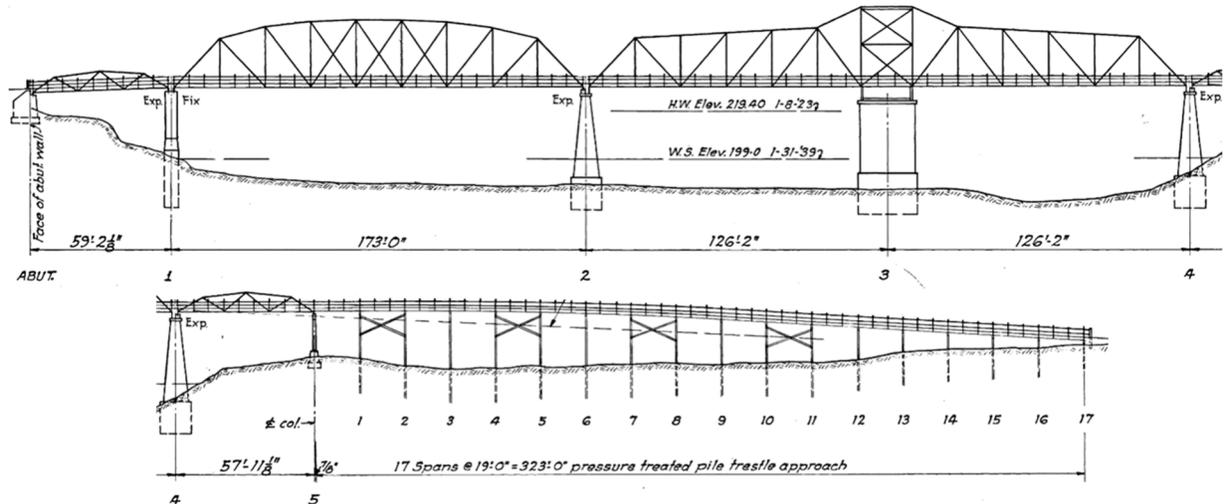
Figure 1 - Van Buren Bridge

Figure 1 shows a profile of the bridge drafted in 1940, before the western approach was damaged.

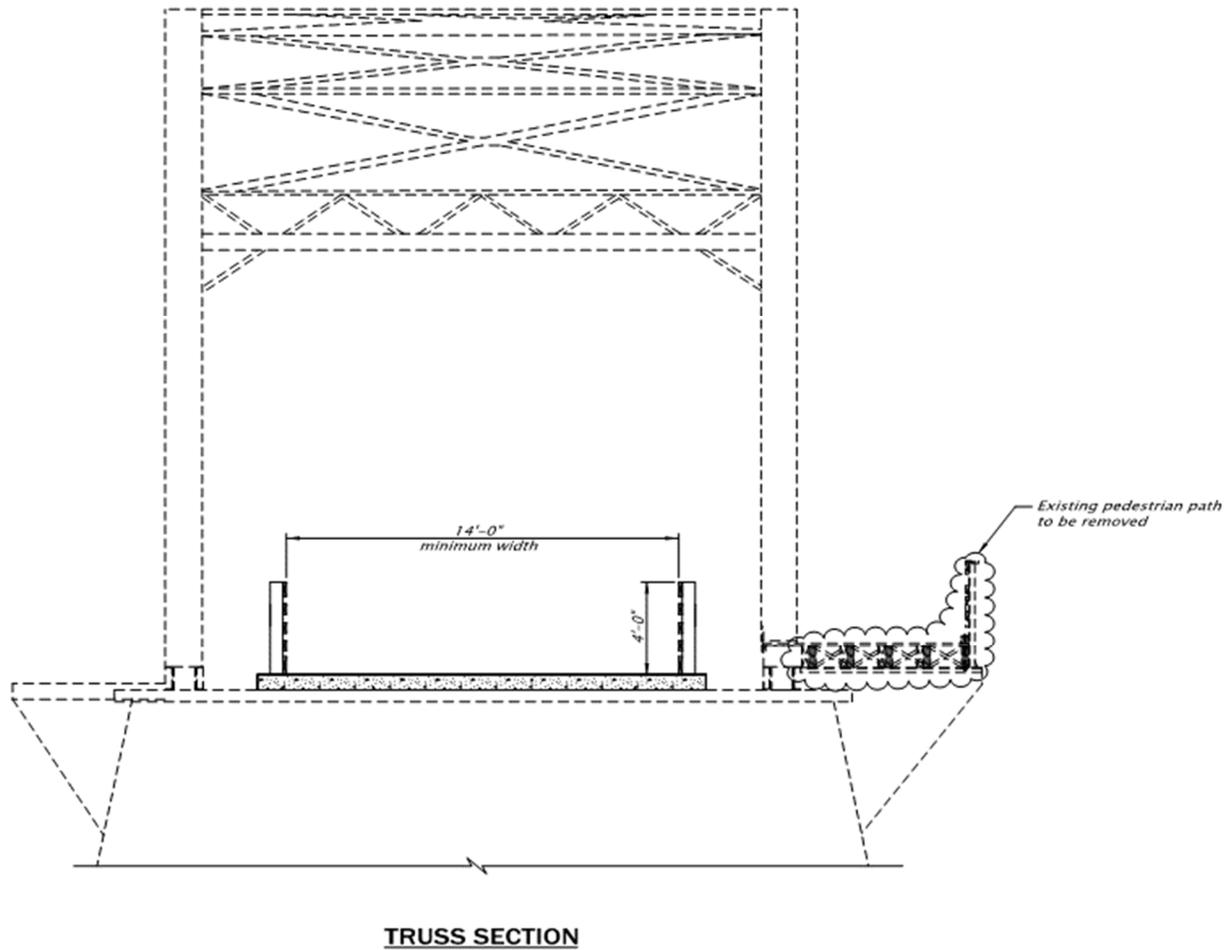
Figure 2 – Conceptual Retrofitting Scheme

To safely accommodate pedestrians on the existing bridge, it would need to be modified. This would require removing the existing sidewalk to prevent its use and retrofitting the main travel lane to incorporate pedestrian safety railing and loading requirements. The approach spans would need to be replaced to make room for the bridge and create new access to the existing bridge. Figure 2 shows a conceptual retrofitting scheme and is included with additional detail in Appendix B.

While it may not seem readily apparent, the American Association of State Highway and Transportation Officials (AASHTO) code indicates that pedestrian loading can exceed the demands of vehicular traffic. The existing bridge is very robust for a structure of its period (in fact it was designed in 1912 for the same live load as a pedestrian bridge would be in 2019), however as design codes have evolved and the bridge has aged, it would need to be evaluated to verify the capacity of the structure in its current condition to carry pedestrian loads. It is possible that either structure strengthening or a load restriction through a reduction in useable width, or both, would be required for public safety. Conversion of the structure to pedestrian use would, with verification of the condition of existing members and implementation of appropriate repairs, if necessary, eliminate the concerns related to the finite fatigue life of the existing structure.

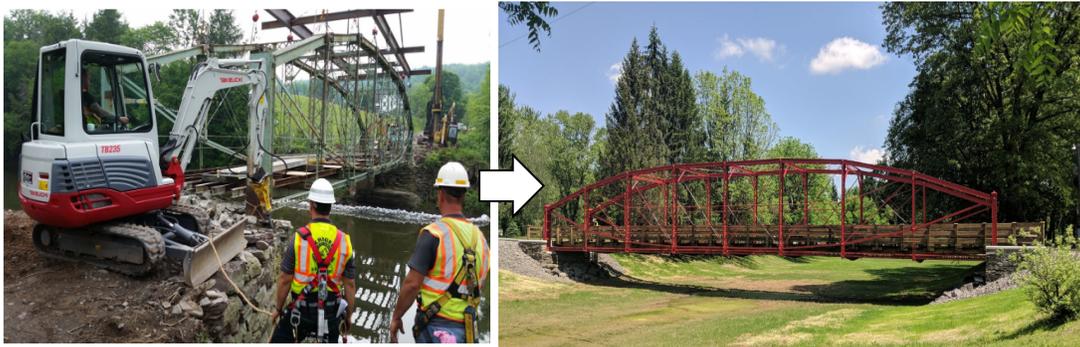
Figure 2 - Pierceville Bridge Relocation (PA)

A new bridge could be constructed in the same location as the existing bridge. In this case, the historic trusses could be relocated to public parks in the area. The steel truss spans would be dismantled and removed from their substructures, with every effort to preserve their historic nature, and then transported for public display or use. The relocated structure could serve as an historical exhibit or as a pedestrian facility if a new deck is placed. Some examples are shown below in Figures 2, 3, and 4.

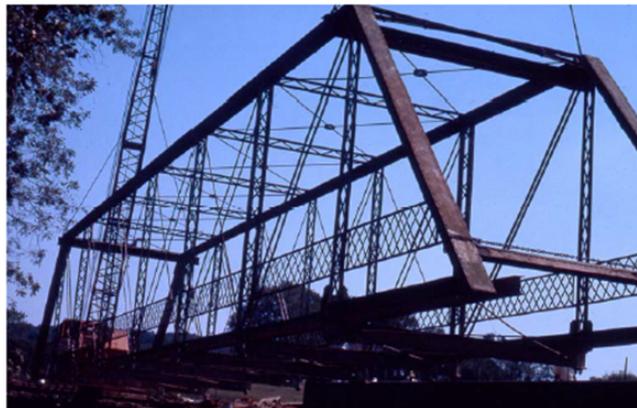
Figure 5 - Crane Lift of Historic Truss

- All the deck materials will be removed on-site before the trusses are dislodged and moved. This common construction practice reduces the structure weight, allowing for smaller, more economical, cranes to be used.

A work bridge would be constructed so that the entire span can be stabilized and removed. The work bridge would likely be constructed on temporary pile foundations. The work bridge may or
